Energy
efficient
Restoration

QSEM: Quick Scan Energy

An energetic balance in raising thermal comfort and reducing energy consumption in Borger's church

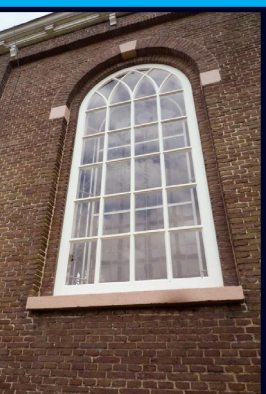
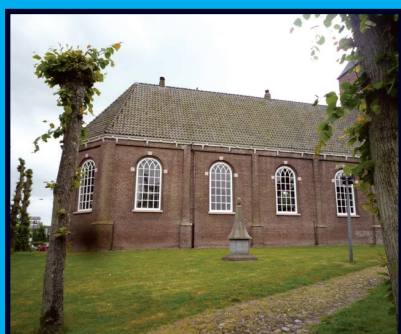
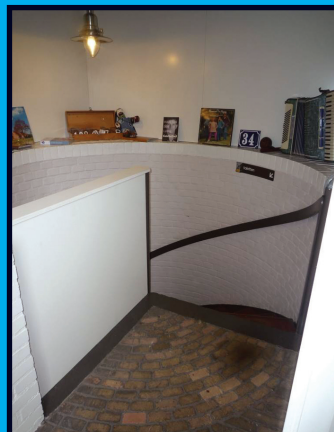
Figure 1 Exterior Bongers' church

Interior after renovation (Annemarie de Groot, 2013) **Figure 2**

When the church was no longer in use for religious activities the former municipality Borger bought and renovated the church so it could be used for the councils' meetings. Therefore some interventions were done: most of the interior was removed, with an exception of the historic organ; a new floor with a floor-heating system was installed, supplemented with a number of radiators. These radiators were placed in niches that were carved out in the thick walls, right underneath the windows. To improve the accessibility of the church an underground hallway between the town hall and the church hall was built. Toilets and installations were located underground next to the town hall. **(Figure 1)**

BUT..... The renter of the buildings quickly understood why the municipality was so enthusiastic about finding a renter: the energy costs were very high! And more important for the renter: no matter how much gas he burned, the visitors were complaining about thermal comfort. Meanwhile, another organisation showed interest in buying the church, allowing the current renter to use the building. But they were only interested if they were provided with recommendations to reduce the energy costs. **(Figure 2)**

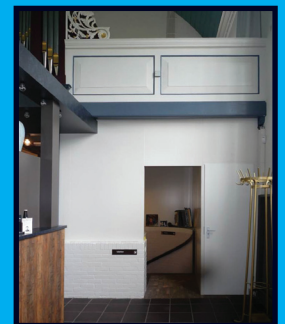
Inventory of the building and installations
(Annemarie de Groot, 2013) **Figure 3**

The technical condition of the building and installations is good. Also different installations are present to provide in the user demands: a heating system (floor heating and radiators), a boiler, and a lighting and sound installation. It is expected that heat is lost through the wooden ceiling, single glass windows, radiator niches, the publicly accessible underground hallway (for fire safety), and by the cracks around doors. Also the heating system may not be efficient for the current use. A floor heating system is sufficient for regular use with about the same number of users, while in the current situation the use is infrequent and the amount of visitors

varies. The adjacent radiators should provide for the peaks of thermal comfort demands. But the heating system might work inefficient because some radiators are placed behind the stage and the distance for transporting hot water is long (through the underground hallway, about 40 meters) . The use of electricity is primarily influenced by the lighting and sound installation. It was also found that the boiler works 24/7, but is not used much. **(Figure 3)**

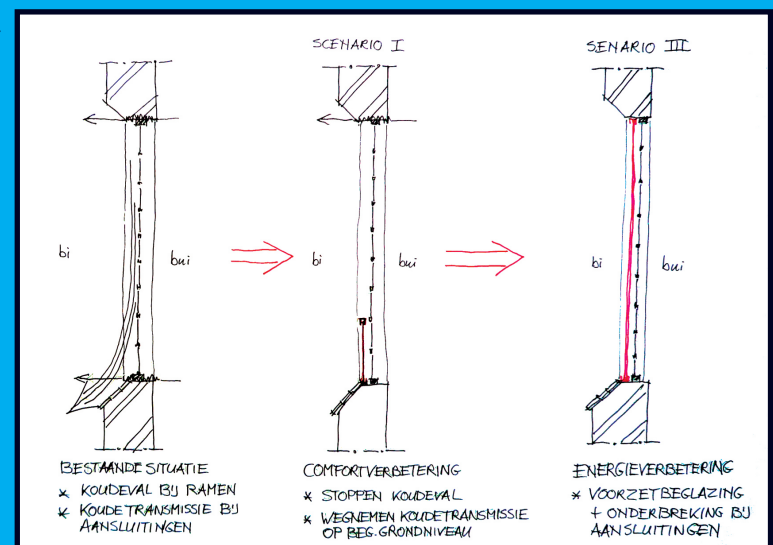
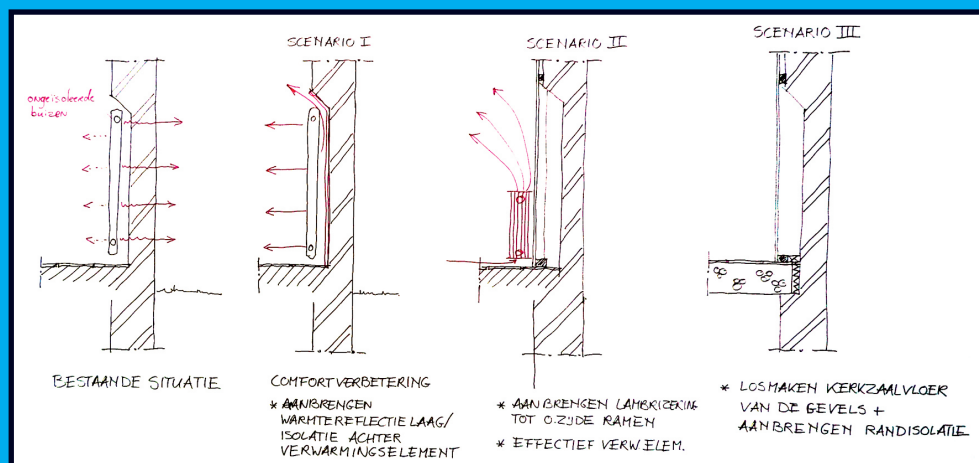
Sketches of alternative scenarios for improving the heating system and the windows. **Figure 4**

With all the collected data, we made a range of energy measures that could be implemented in four scenarios (see Figure 4). So the owner can choose to implement one of more scenarios when the time is right (or the money available).

- Easy-to-apply measures to improve thermal comfort: heat or physical curtain to the entry of the underground hallway, adding an extra door in the hallway to the (cold) tower, crack sealing, replace the boiler for a kettle, using blankets for smaller (more personal) activities and monitoring the energy consumption to find out whether the building and energy management could be done more efficient.

- Minor modifications to the building and installations: improving the efficiency of the existing situation by placing insulation behind the radiators, stop using radiators behind the stage and using a more easy control system for heating.

- Major interventions to the building and installations: applying a cooling system, heat recovery in a ventilation system, adding an enclosed entrance area, build an extension for toilets and storage which may also be used for a heating system (shortening the distance of heat transport).
